P R E S S   R E L E A S E

## **NEW CLEANING LINE IMPROVES MANUFACTURING PROCESSES AS WELL AS COMPONENT QUALITY**

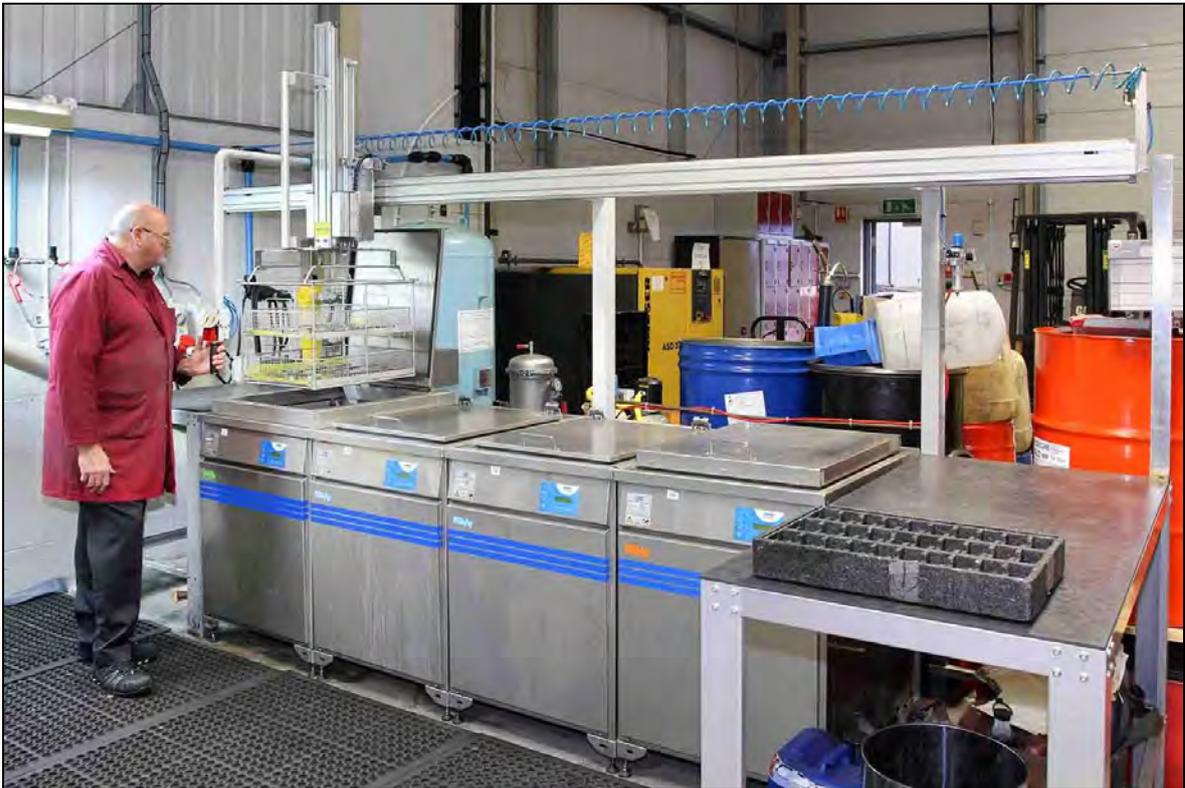
1. Bob Savory about to immerse a batch of machined stainless steel components into the first tank of the multi-stage Turbex Versa aqueous cleaning line at Norman Precision, Stonehouse.

On arrival at the cleaning line, a batch of components is placed in a stainless steel basket, which has its base lined with a plastic mesh to prevent damage to the surfaces of the parts. With the help of an overhead gantry along which a pneumatic lifting device moves, the operator transfers the load to the four tanks in sequence. All are held at a temperature of 50°C, which accelerates the cleaning and drying while allowing the components to be handled immediately after processing.

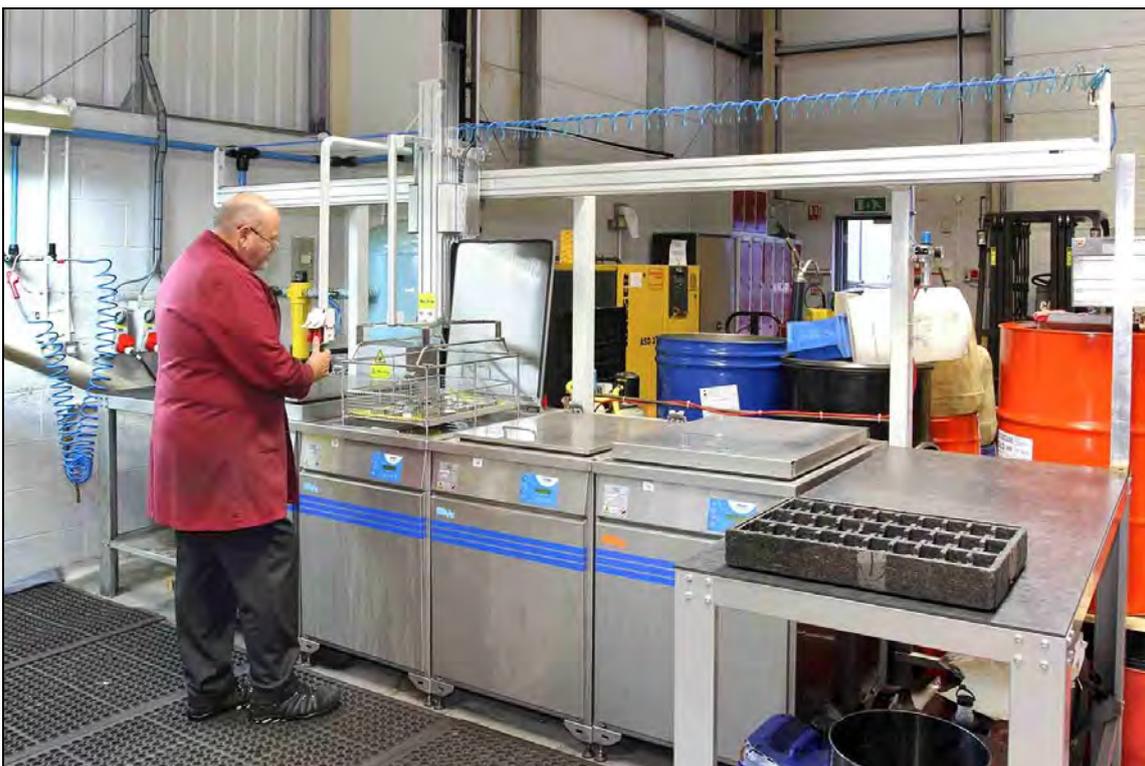
2. After completing 10 minutes in the ultrasonic tank with detergent, the load is lifted into the second tank for rinsing in tap water for one minute.

Tank 1 contains tap water with detergent and an ultrasonic oscillator to assist removal of particulates and other residue. The action is enhanced by short, automatic movements of the basket up and down. This technique is copied at the two subsequent stages. The water is periodically cleansed by pumping it through a coarse and fine filter into an adjacent recirculation cylinder from where the tank is replenished. Meanwhile, the ultrasonics are turned off to save energy.

After 10 minutes, the basket passes to the second and third stages for one minute each. The first contains tap water agitated by compressed air

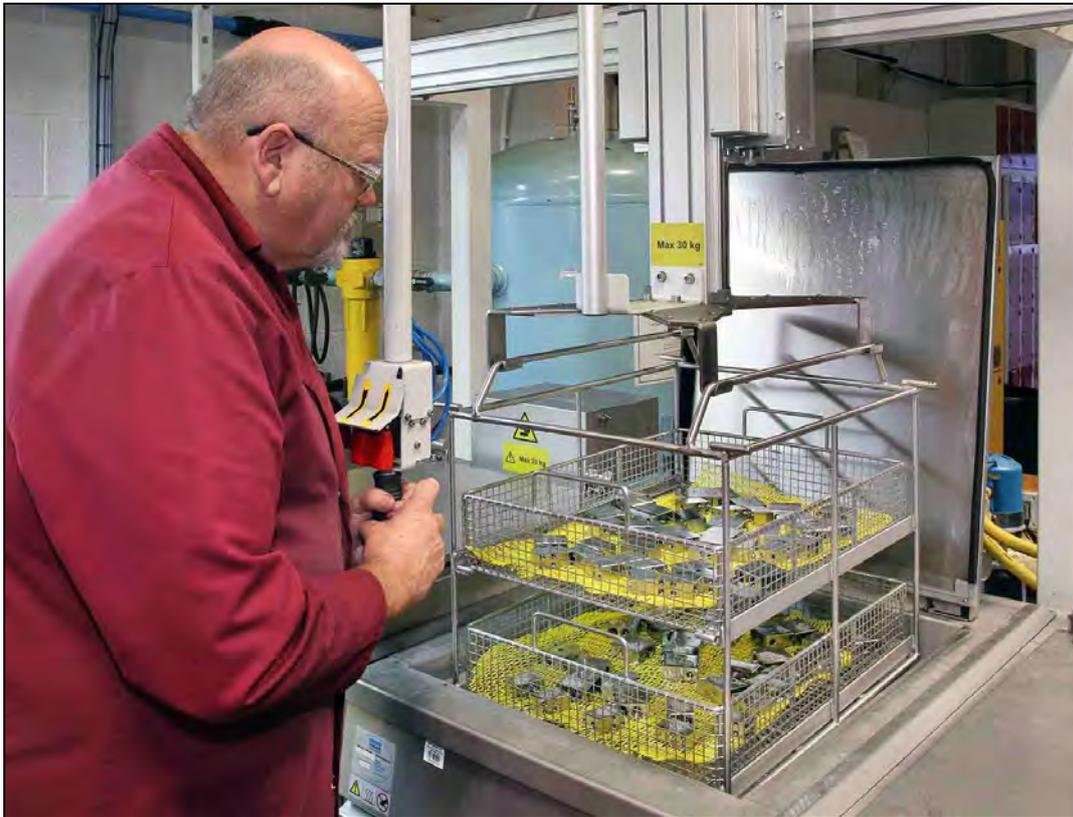
3. Close-up of the stainless steel components about to enter tank 2, with the assistance of the gantry-mounted lifting device.

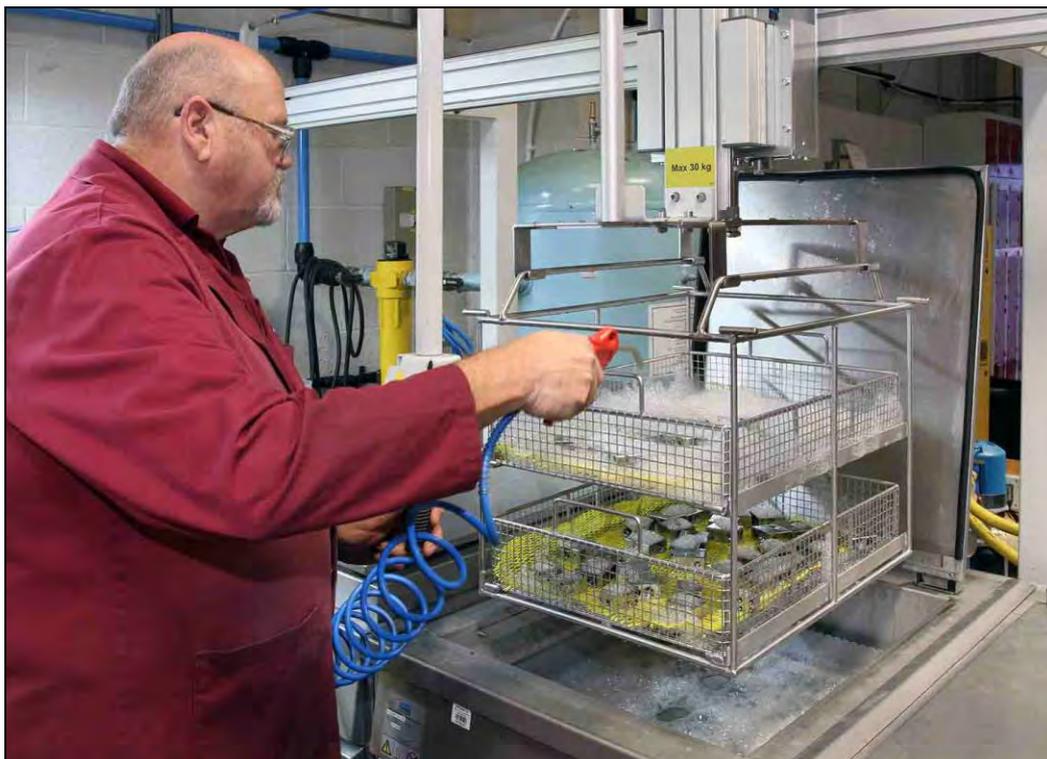
4. After the basket emerges from the second tank, soapy residue is removed using an airline to prevent undue contamination of the deionised water in the next rinse tank.

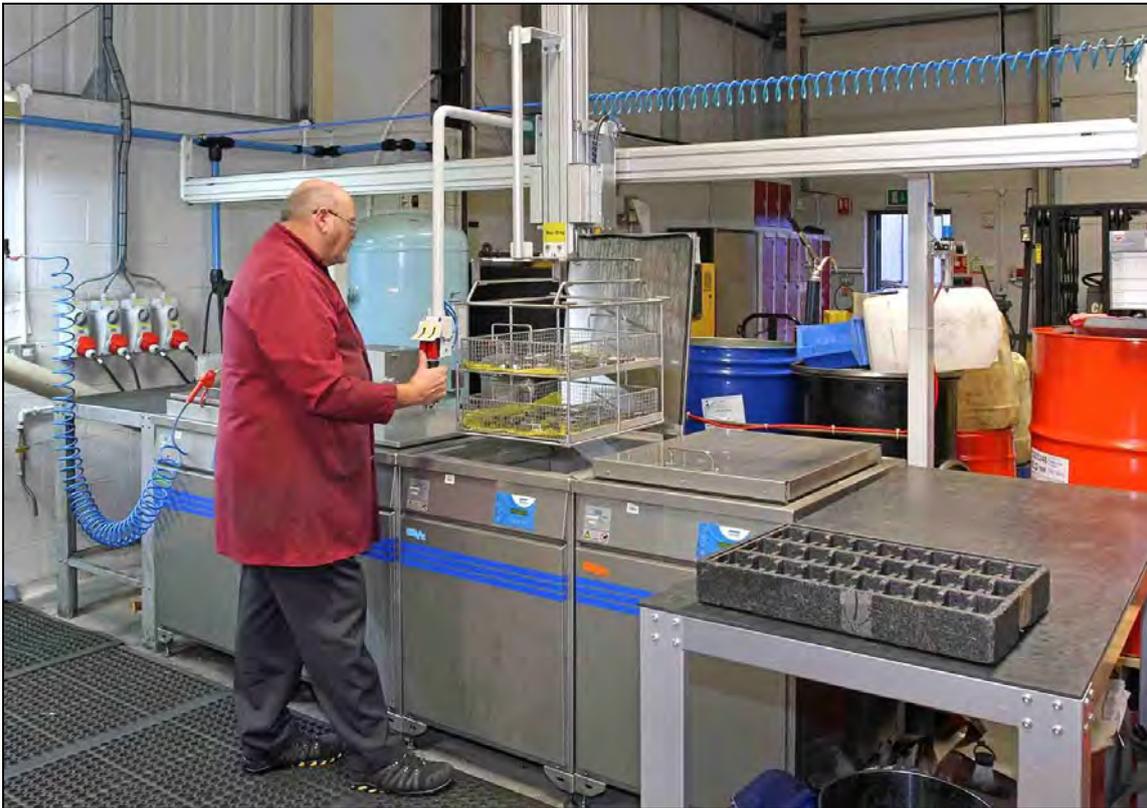
5. The load about to enter tank 3 for the deionised water rinse.

and the second is filled with water that is continuously deionised by an active carbon cylinder followed by an ion exchange resin cylinder.

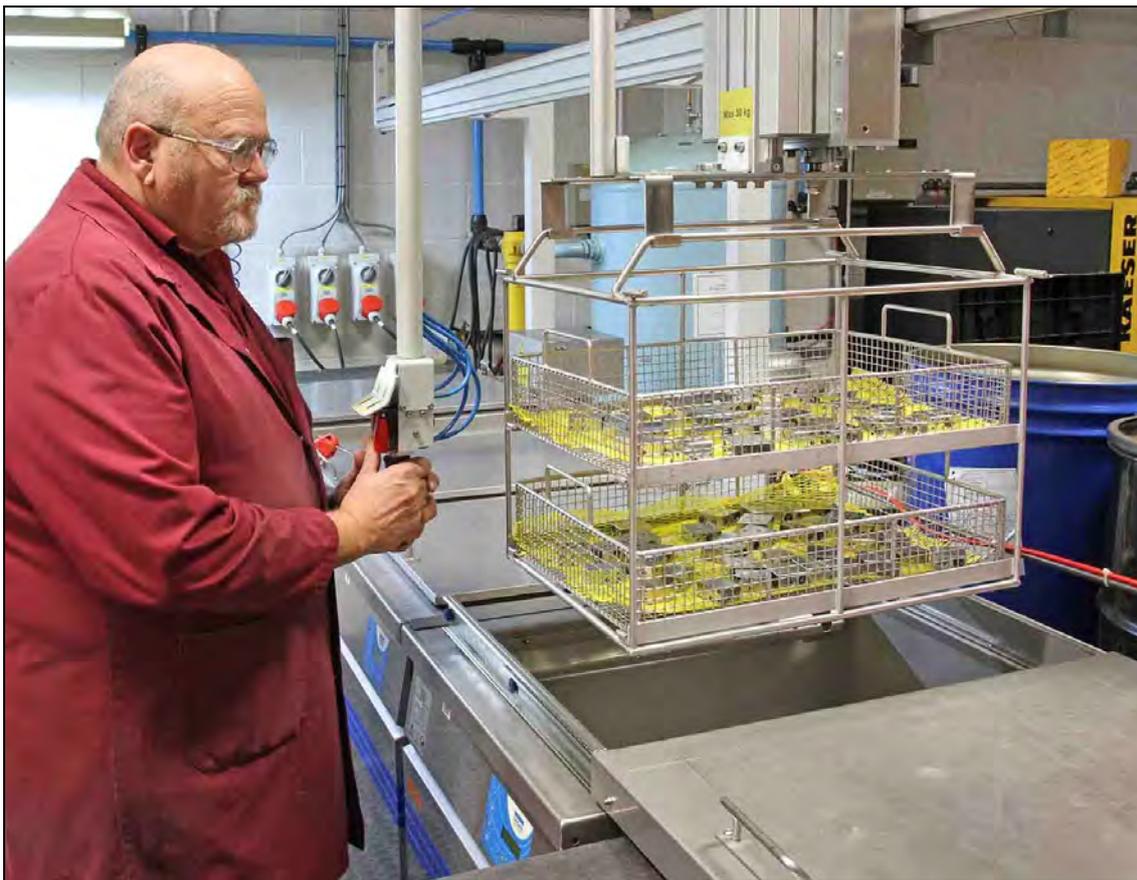
6. The fourth, drying stage about to start.

The last stage is an air-assisted dryer in which components spend 10 minutes, after which all of the water has usually evaporated.

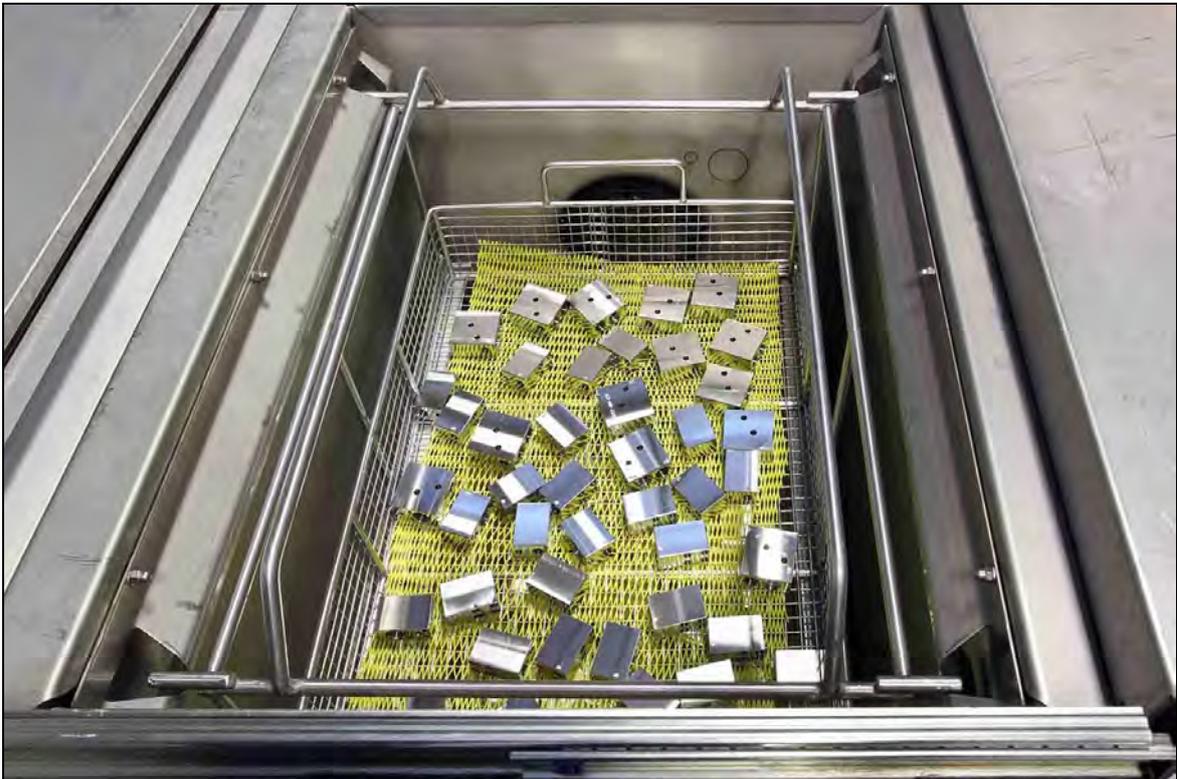
7. A view of the stainless steel components after drying.

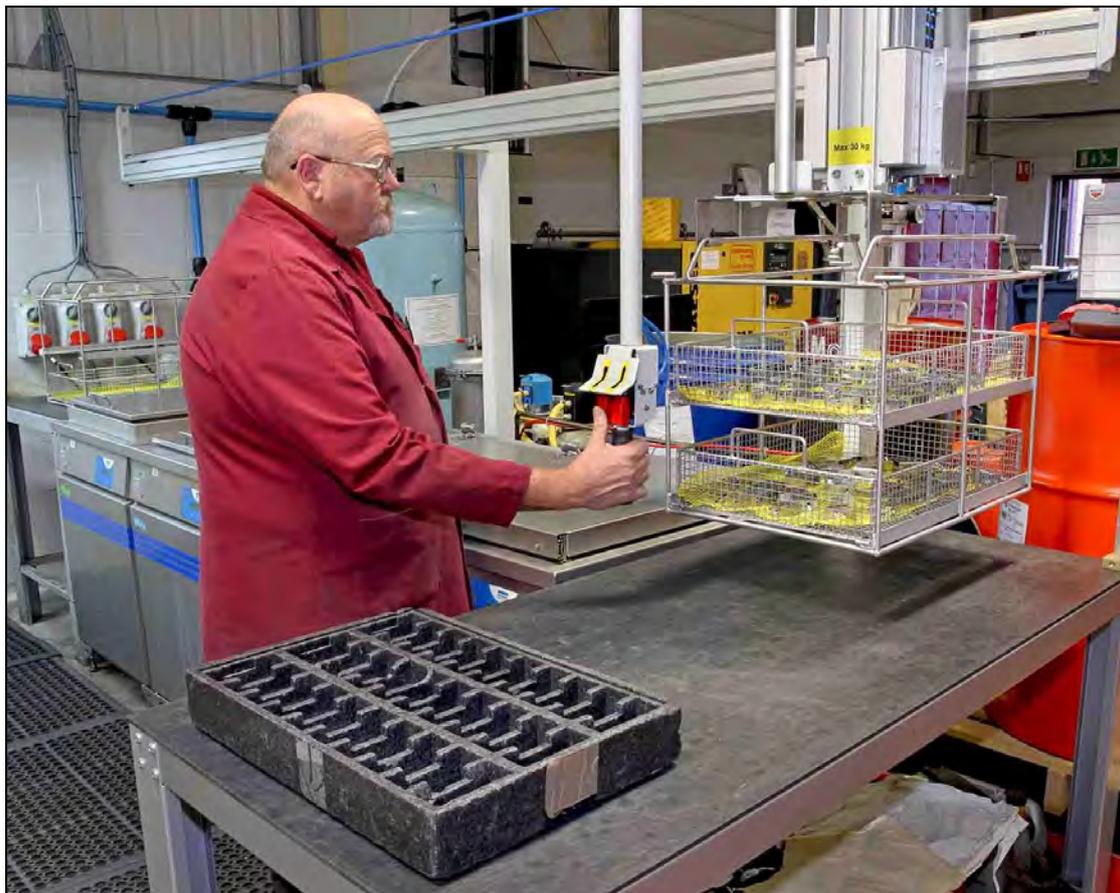
8. Dry components being lifted out of the tank and deposited on a work bench.

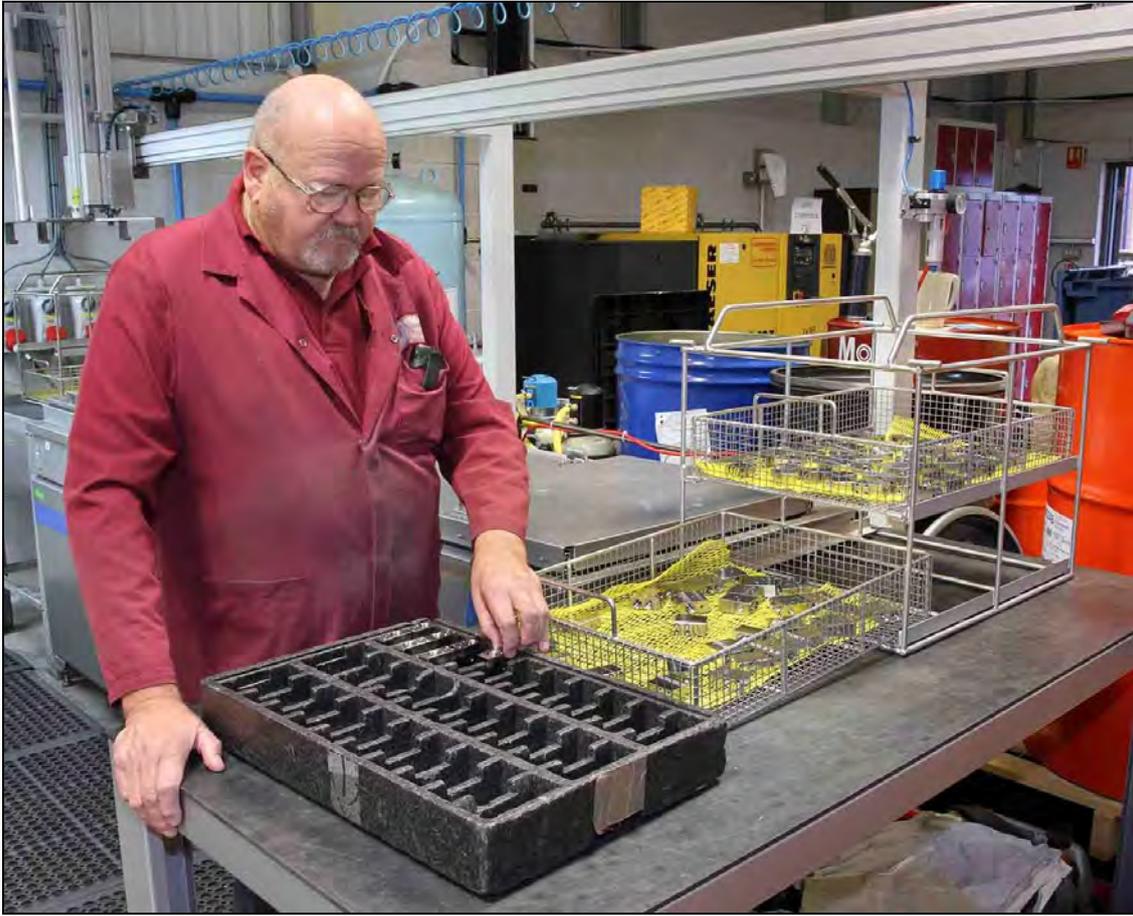
9. As the components are at 50°C and reducing in temperature rapidly, they are conveniently handled without gloves into trays for delivery to the customer or an external finisher.
